CASE STUDY FOR THE GOOD LONG-TERM SERVICEABILITY OF INTERLOCKING BLOCK PAVEMENT

Summary

Thus, the investigation of serviceability was conducted at the two in-situ locations (the bus terminal around the train station that was built 18 years ago and the roadway that was built 27 years ago). This paper reports those findings of investigation.

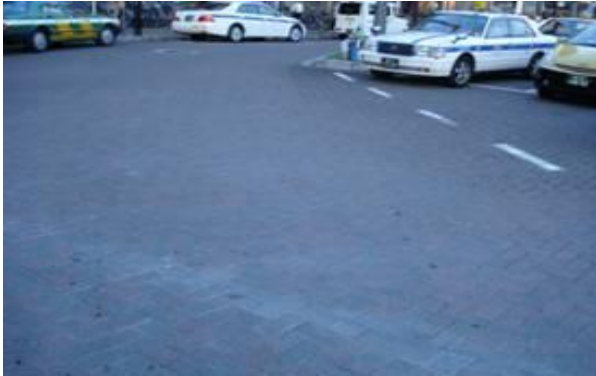
Figure 2. Sound condition at entrance and corner.

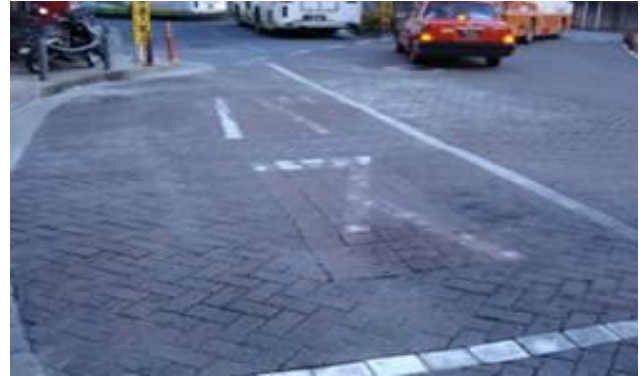
Figure 3. Sound condition at bus station.

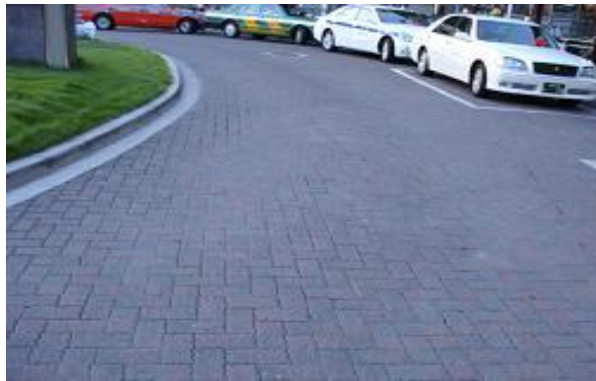
Figure 4. Rutting near taxi bay.

The mean rutting depth of the bus station in the sound and damaged section were 2.6 mm and 12.6 mm respectively. As well, rutting of taxi bay in the sound and damaged section were 17.9 mm and 5.5 mm respectively. The largest depth was 17.9 mm at the taxi bay in the damaged section. Including this section, all sections satisfied the JIPEA maintenance standard value (i.e., less than 30 mm). Thus, the condition of rutting depth was roughly sound.

The mean thickness of bedding sand of the bus station in the sound section and damaged section were 29 mm and 23 mm respectively. It can be said that the bedding sand of consolidation deformation caused the larger rutting in the damaged section than that of in the sound section.

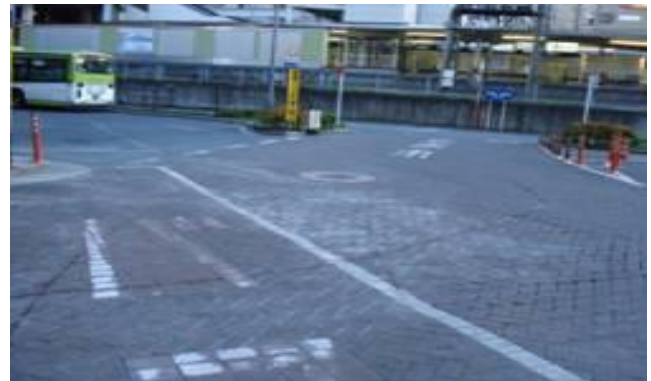
As shown in Figure 1, bitumen stabilization was used for base course and the design of traffic volume was N5 (number of commercial heavy vehicle 250~1000 /day-direction). The design CBR of subgrade was 3%. The road surface condition of IL block pavement was comparatively sound at the sections from near the terminal entrance to cornering region of taxi bay and bus stop as shown in Figure 2 and Figure 3. However, rutting occurred partially in the cornering region of taxi bay and bus stop, and a spout of joint sand and bedding sand due to the settlement and pumping was observed as shown in Figure 4 and Figure 5.

Figure 5. Damaged area at part of bus station.

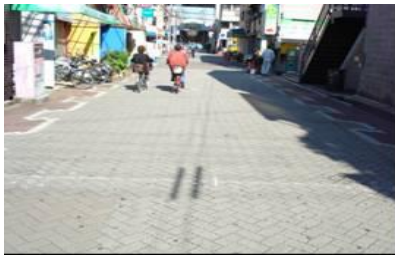
Site A

The surface conditions of IL block pavement at three sites are shown in Figure 6. In a whole are of 642 m² at site A and B, there were repair marks in about 250 m² repaired by new material. This was due to the restoration construction (water service and drainage), but not the repair with the pavement distress. As long as visual survey, there was no significant damage. The surface condition was excellent.

Figure 7. Surface condition (27 years serviceability).
