CASE STUDY FOR THE GOOD LONG-TERM SERVICEABILITY OF INTERLOCKING BLOCK PAVEMENT

Summary

Thus, the investigation of serviceability was conducted at the two in-situ locations (the bus terminal around the train station that was built 18 years ago and the roadway that was built 27 years ago). This paper reports those findings of investigation.

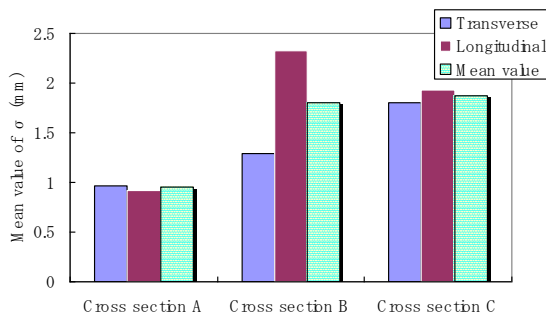
Figure 7. Results of roughness σ

Results of the mean value of roughness are shown in Figure 7. As shown in this figure, the minimum value occurred in site A whose base course thickness is thick. All results satisfy the JIPEA maintenance standard value of 5 mm. Thus, as long as roughness, the condition was excellent.

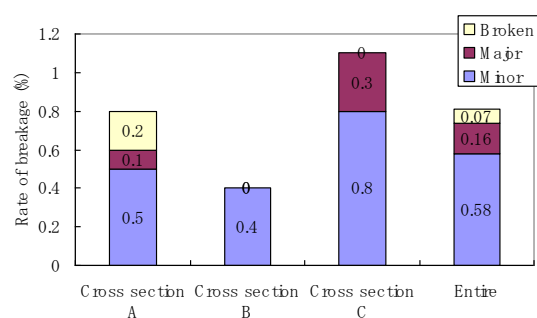
Figure 8. Results of rate of blockage

Results of rate of block breakage are shown in Figure 8. As shown in this figure, all results satisfy the JIPEA maintenance standard value 20%. The damages are only minor broken edges. Thus, as long as the rate of block breakage, the condition is excellent.

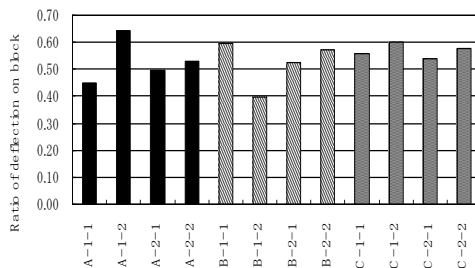
Figure 9. Results of ratio of deflection of block.

Figure 9 indicates the result of the ratio of deflection of block surface measured by handy FWD. As shown in this figure, all ratio of deflection in 3 sites are almost all the same. Hence the effect of load distribution by IL block is excellent. Additionally, by comparing with the above-mentioned results in bus terminal, these ratios of deflection are larger than those of above-mentioned. Hence, the effects of load distribution are larger.
